SPECIFICATION  
OF  
THERMOPILE  
INFRARED SENSOR

MODEL NO. TS-1NMB

| | | NIPPON CERAMIC CO.,LTD. | | |

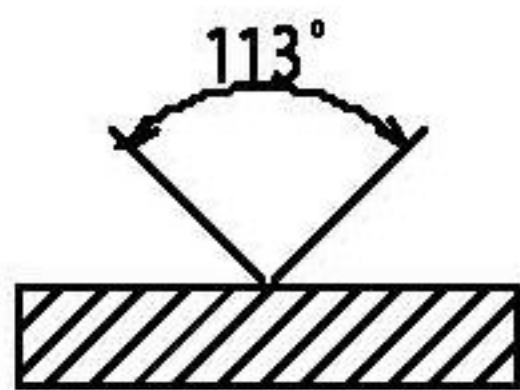
FIELD OF VIEW  
(FIGURE 1-A)

- 1) FIELD OF VIEW : 113° FROM CENTER OF SENSITIVE ELEMENT  
: SEE FIGURE 1-A
- 2) FILTER SUBSTRATE : SILICON

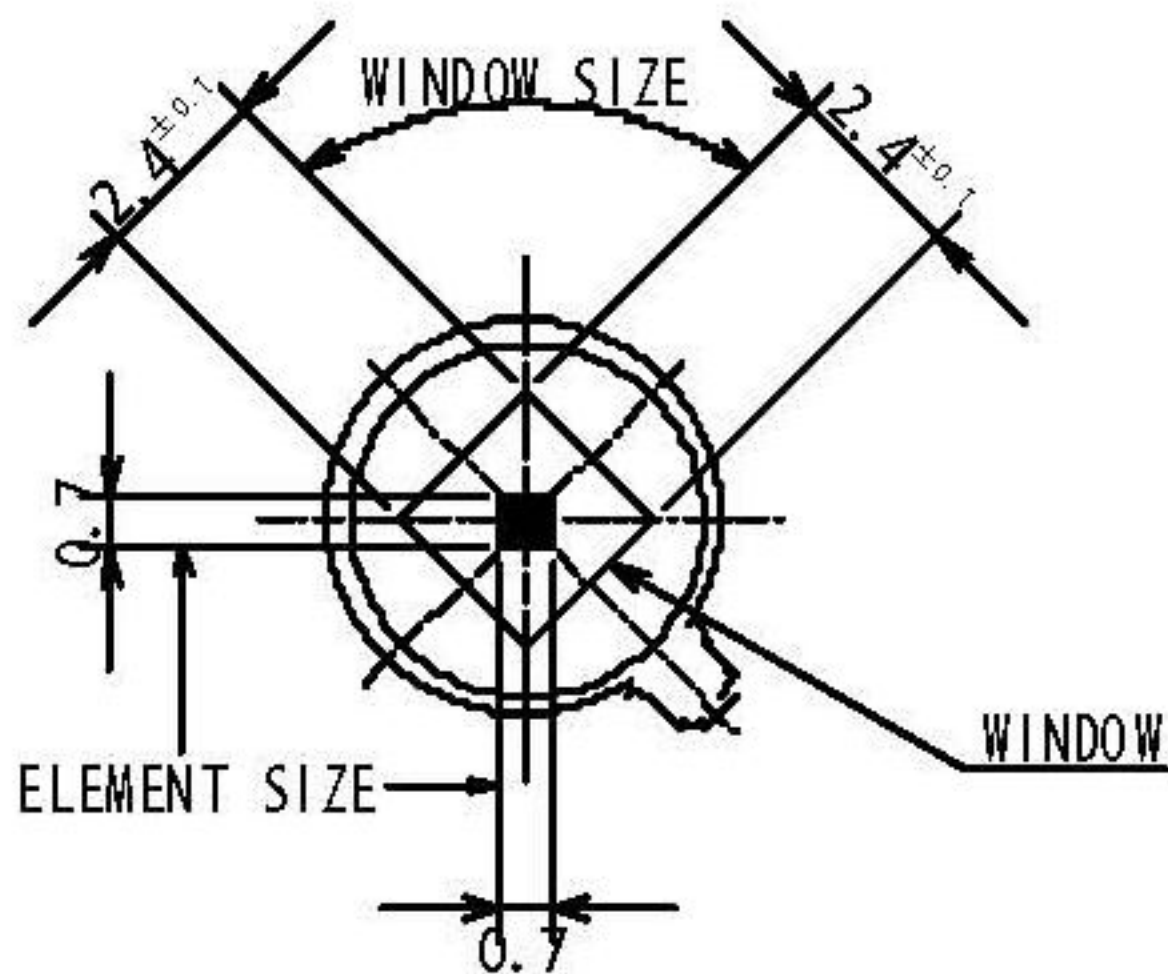
TOP VIEW  
(FIGURE 1-B)

- 1) PACKAGE : TO-18 METAL CAN WITH DIMENSIONS SHOWN IN FIGURE 1-C  
(GOLD-PLATED)
- 2) ELEMENT GEOMETRY : SENSITIVE AREA 0.5 mm<sup>2</sup>
- 3) ELEMENT ORIENTATION : SEE FIGURE 1-B
- 4) LEAD CONFIGURATION : SEE FIGURE 1-C, 1-D

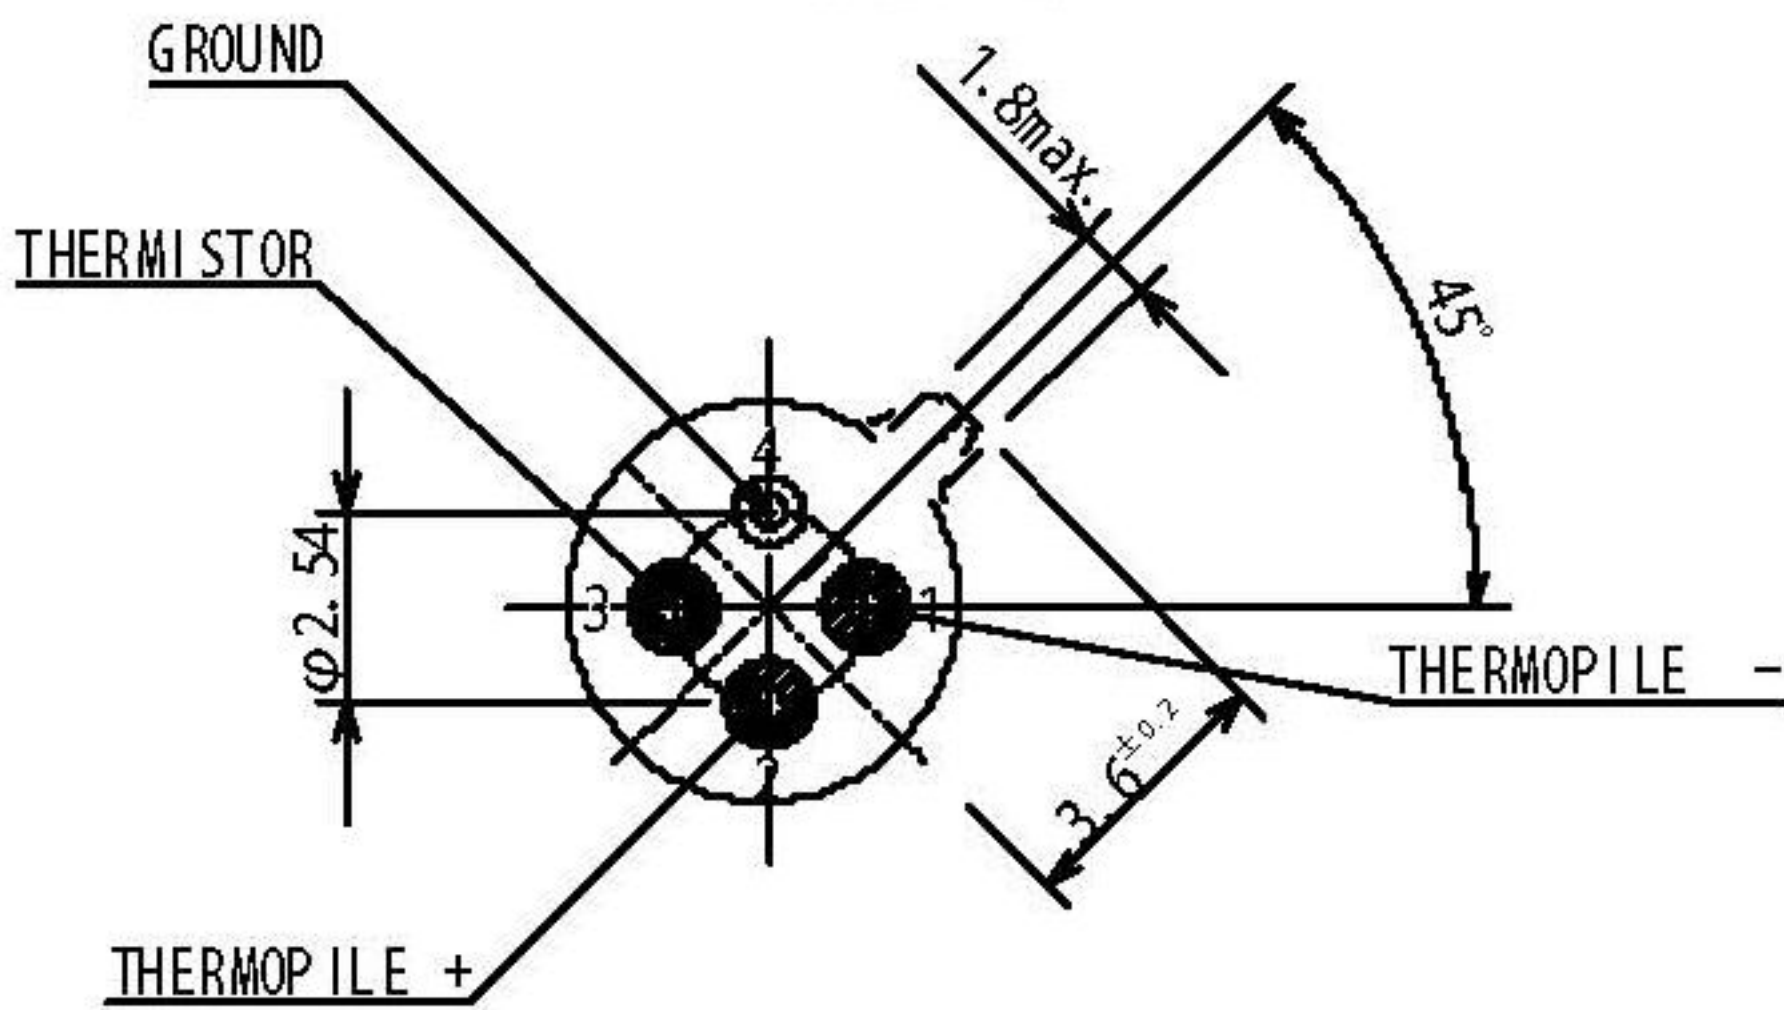
BASE VIEW  
(FIGURE 1-D)

- 1: THERMOPILE -
- 2: THERMOPILE +
- 3: THERMISTOR
- 4: GROUND

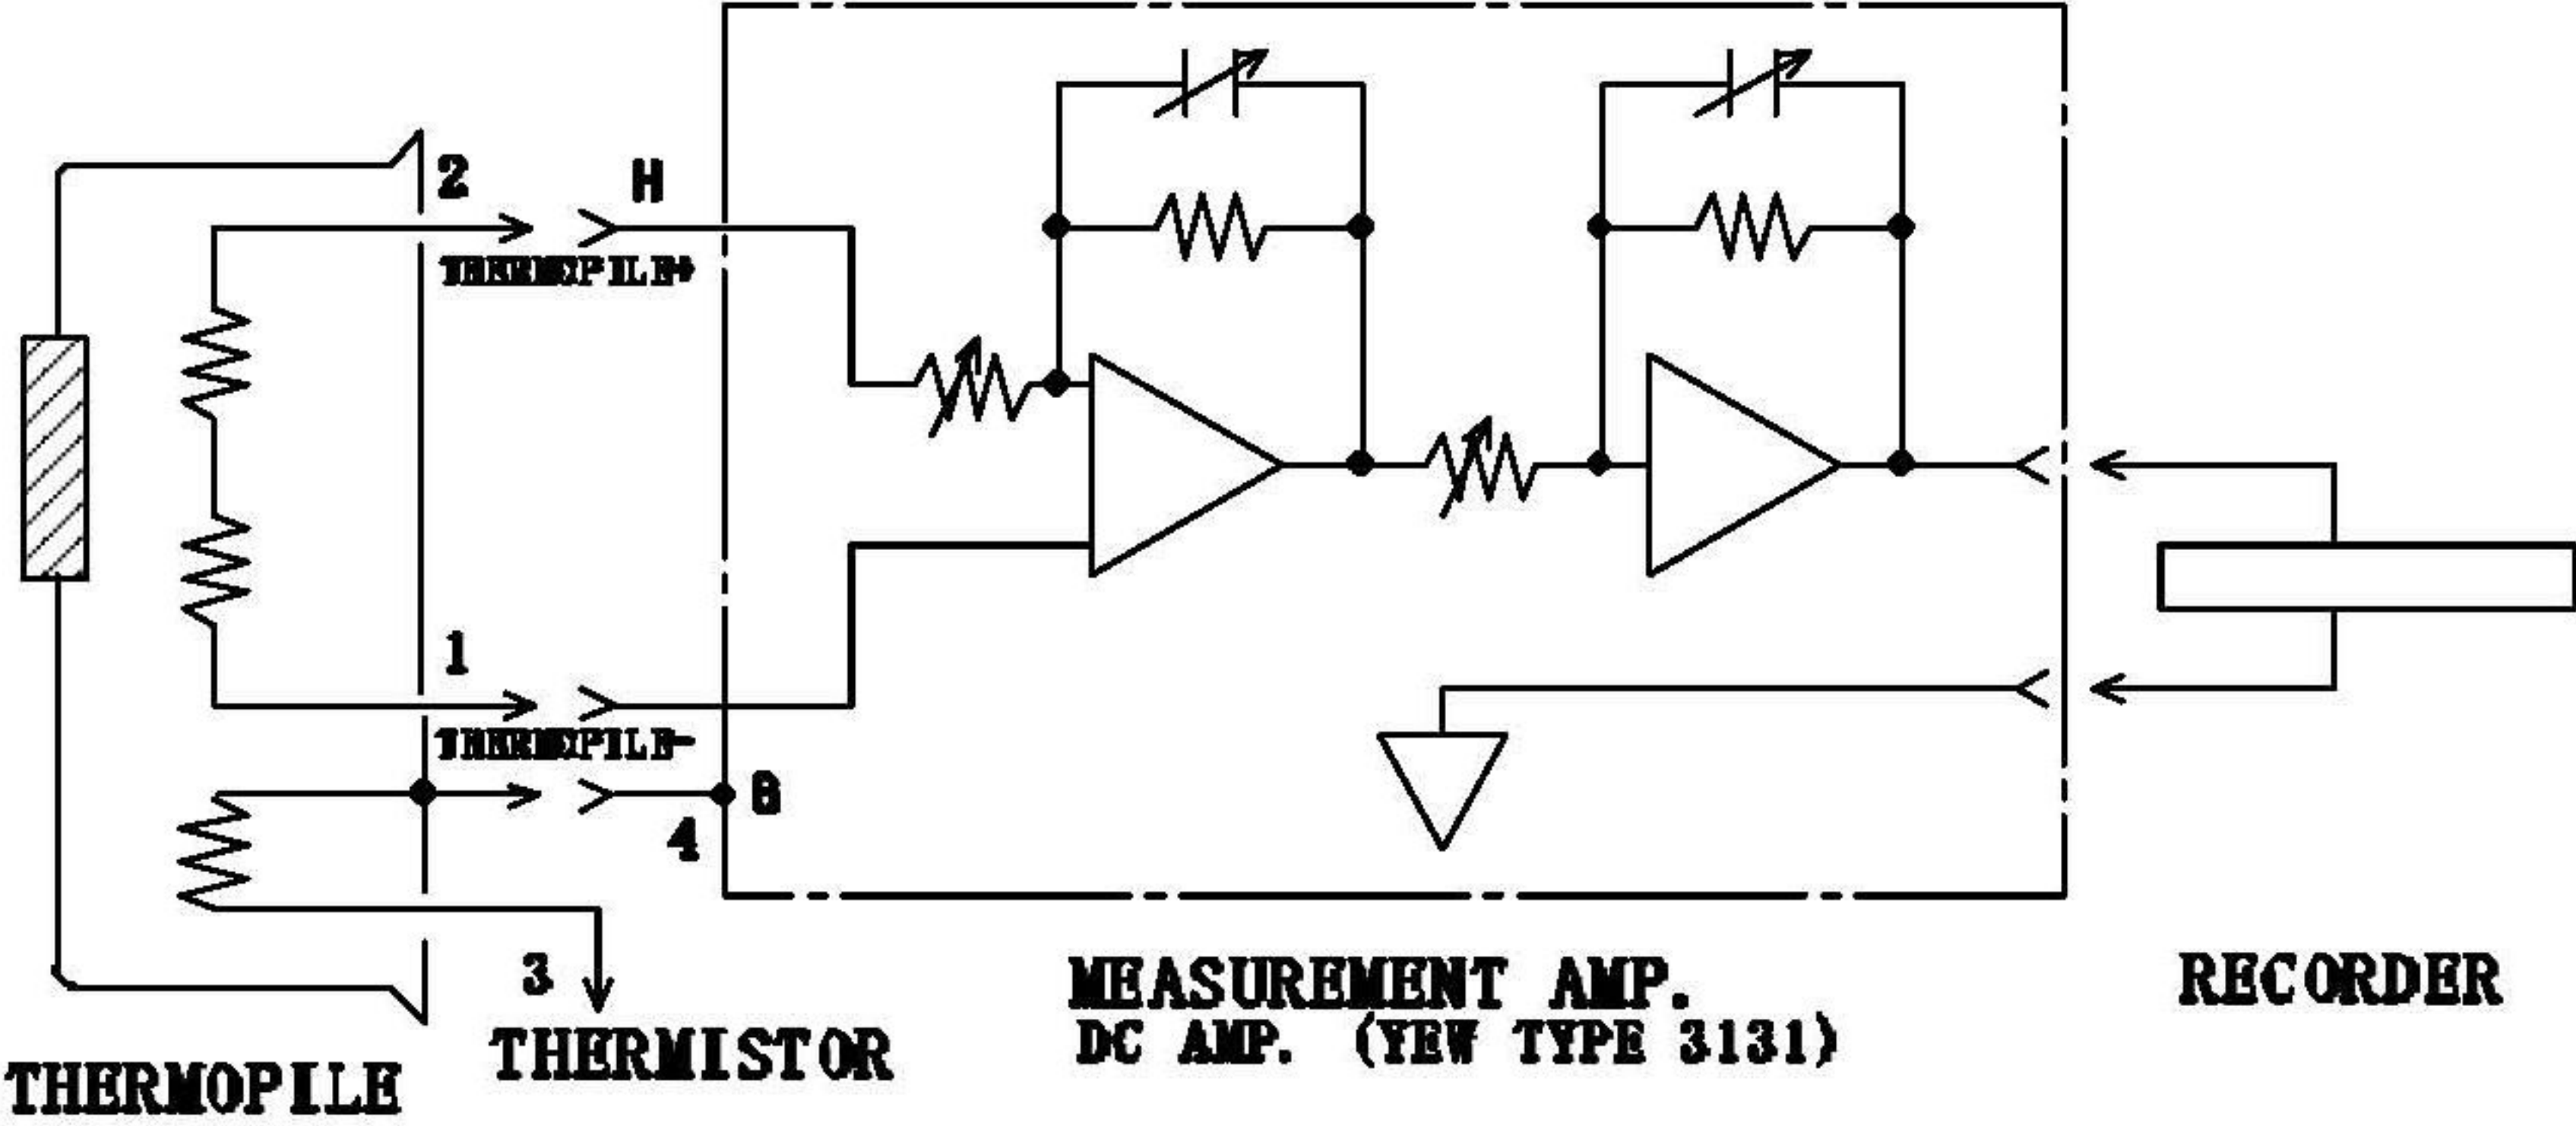
CIRCUIT CONFIGURATION (FIGURE 2)

- 1) CIRCUIT CONFIGURATION : FOUR-TERMINAL SENSOR  
SEE FIGURE 2
- 2) SIGNAL OUTPUT : 200 mVo-p ± 30%

- 3) RESISTANCE OF THERMOPILE (Pin 1 ~ Pin 2)  
: 50KΩ ± 15 KΩ (at 25°C)
- 4) REFERENCE RESISTOR (Pin 3 ~ Pin 4)  
: 100KΩ ± 10% (at 25°C)

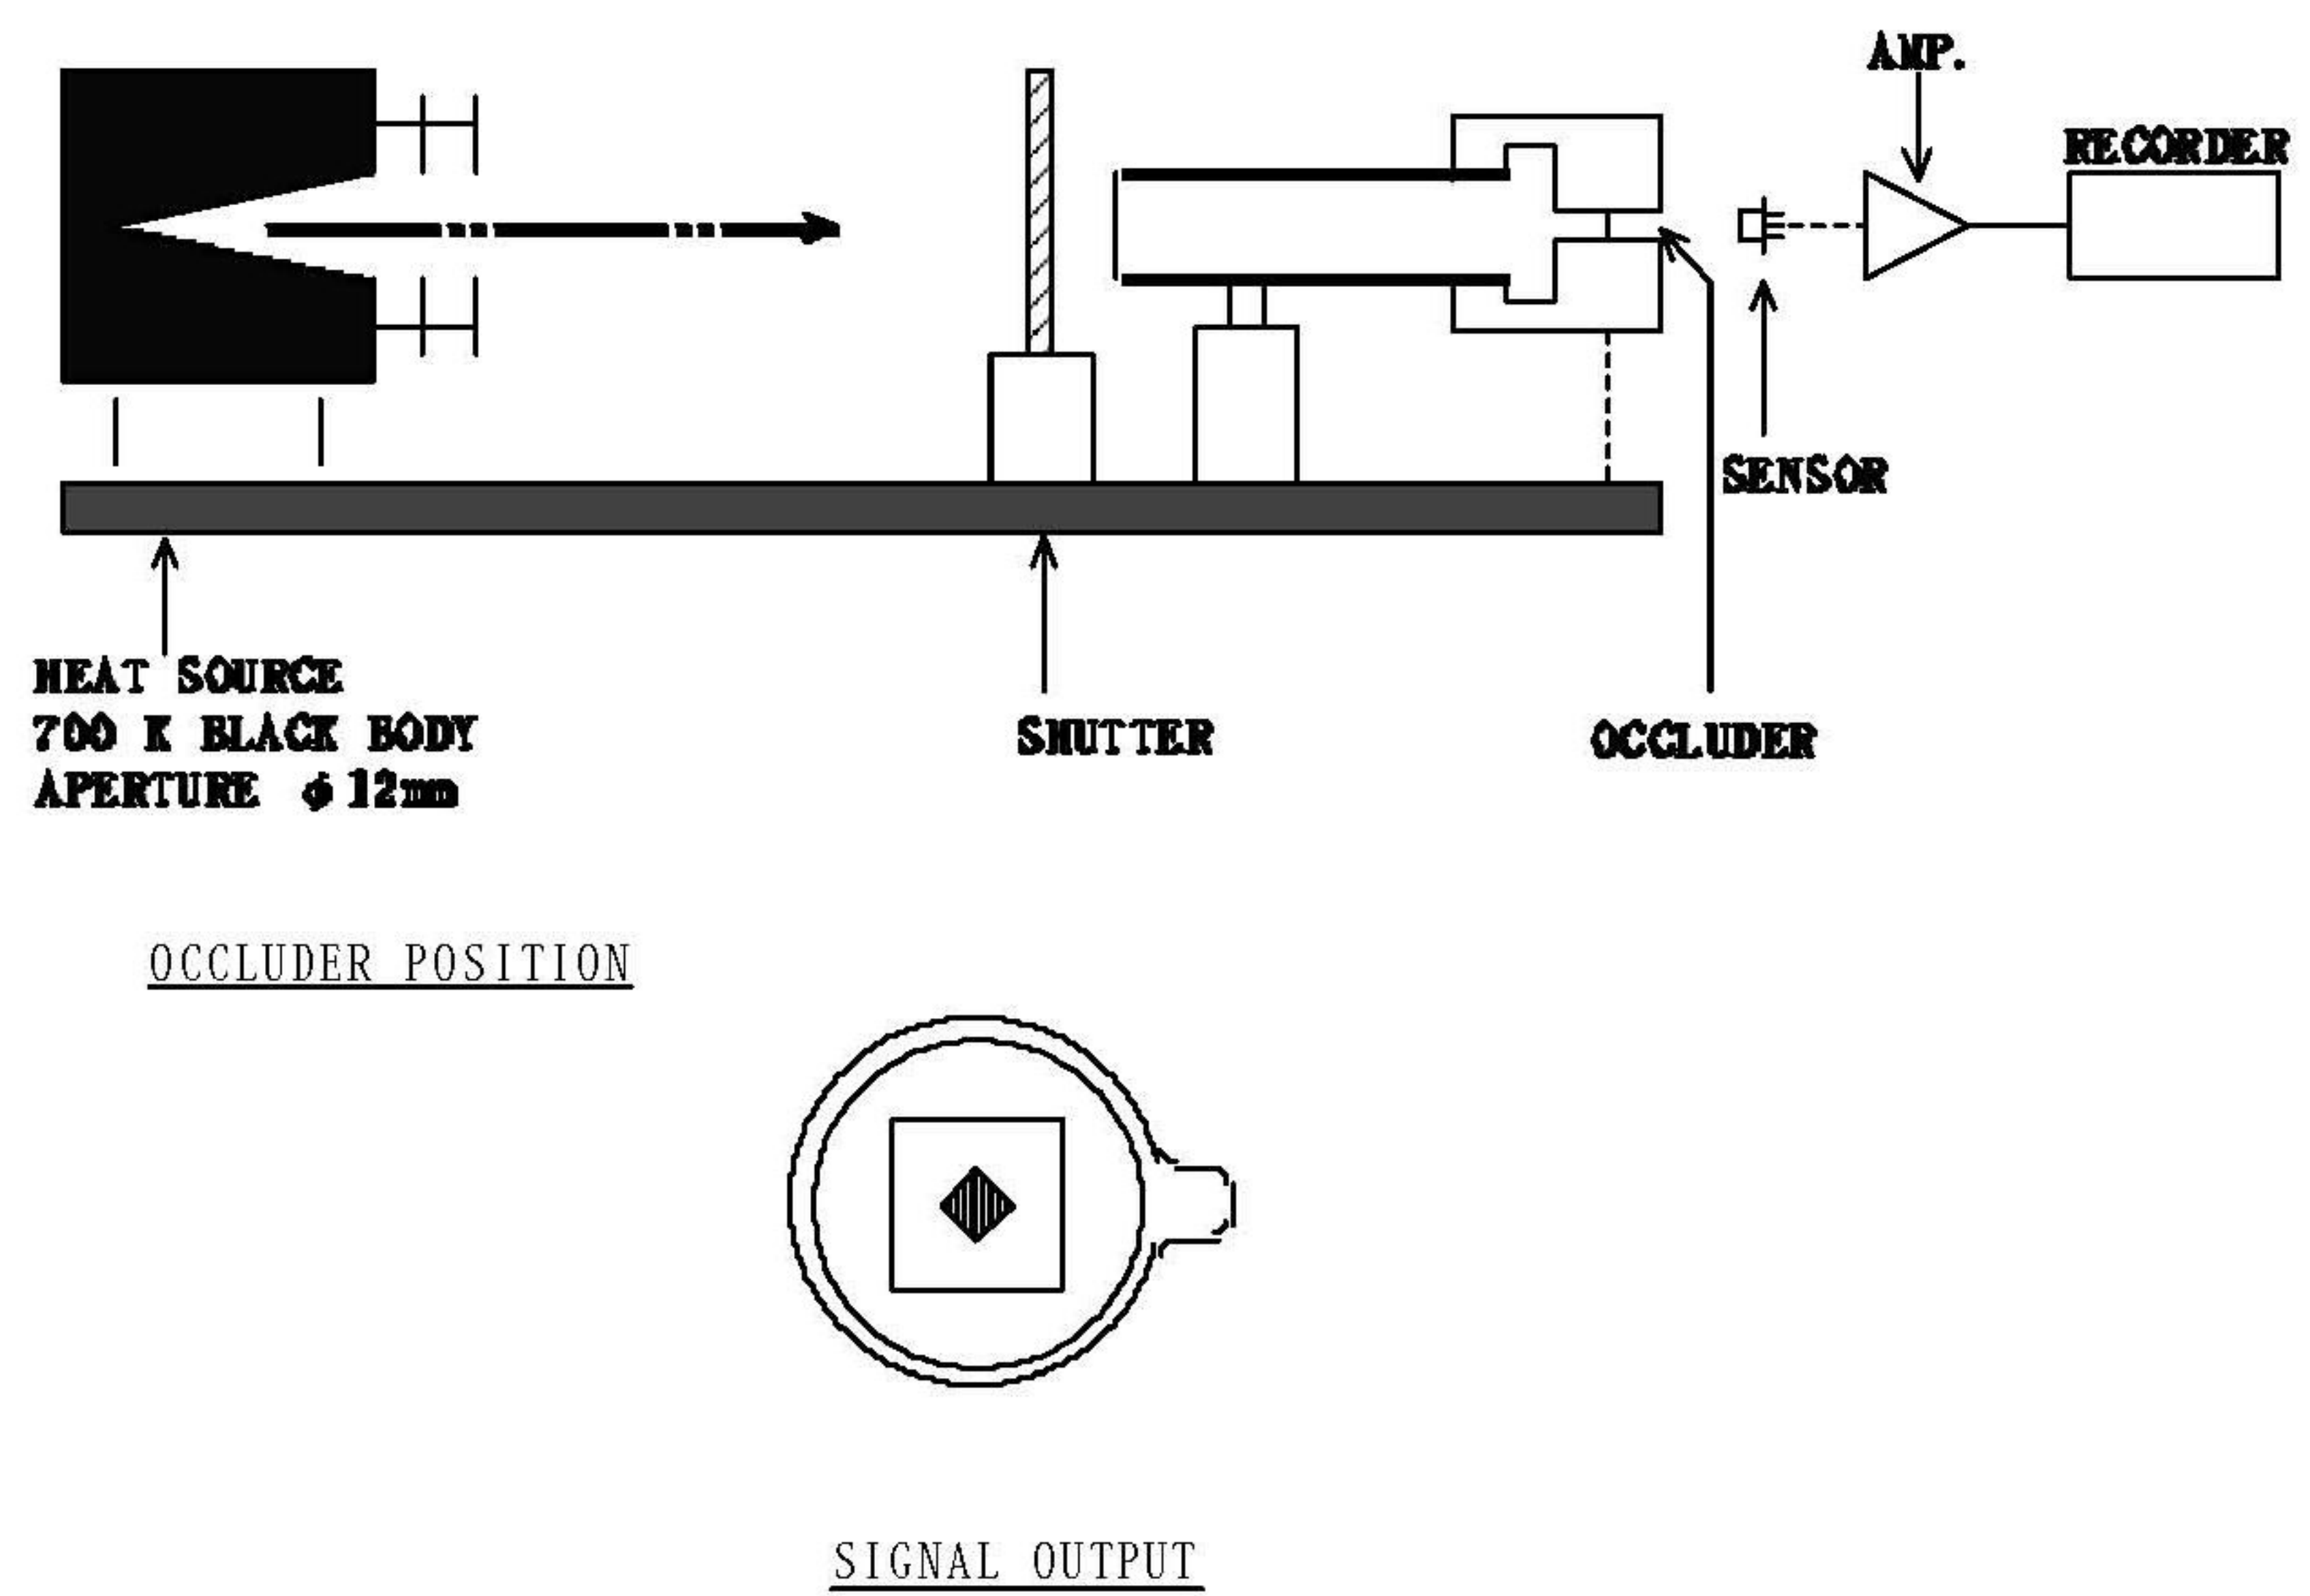
TEST SET-UP BLOCK DIAGRAM (FIGURE 3)

SIGNAL OUTPUT IS MEASURED BY USING SHUTTER WHEN CONNECTED TO THE AMPLIFIER OF  
GAIN 74 dB (AT 1 Hz) AND SUBMITTED TO THE EMISSION OF INFRARED ENERGY OF  
167 μW/cm<sup>2</sup> FROM 700K BLACK BODY.  
SEE FIGURE 3

※ MEASUREMENT AMP.: DC AMP. YEW TYPE 3131, GAIN 74 dB AT 1 Hz.
